Cadmium Alternative Studies for C-17 P² Projects

Qualification of Sputter Aluminum for C-17 Program

2002 Demo at Hill AFB for C-17 Program

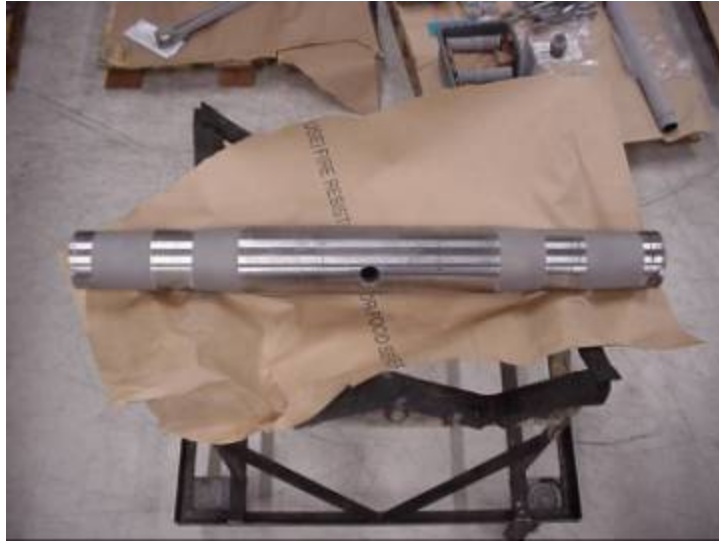
C-17 Axle Before Coating

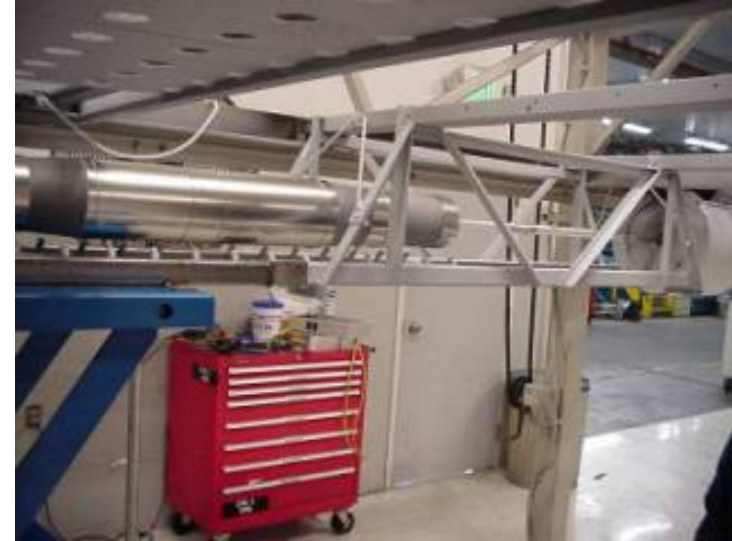
C-17 Axle Loaded on Coating Rack

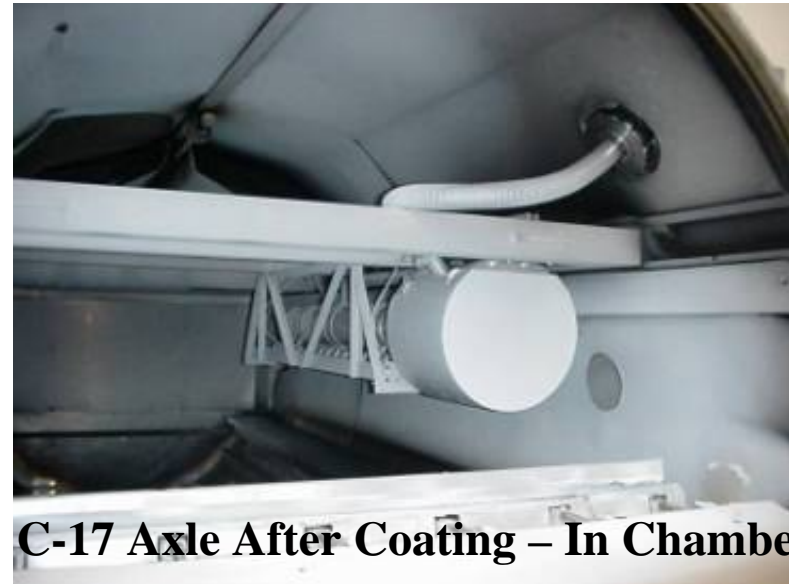
C-17 Axle After Coating – In Chamber

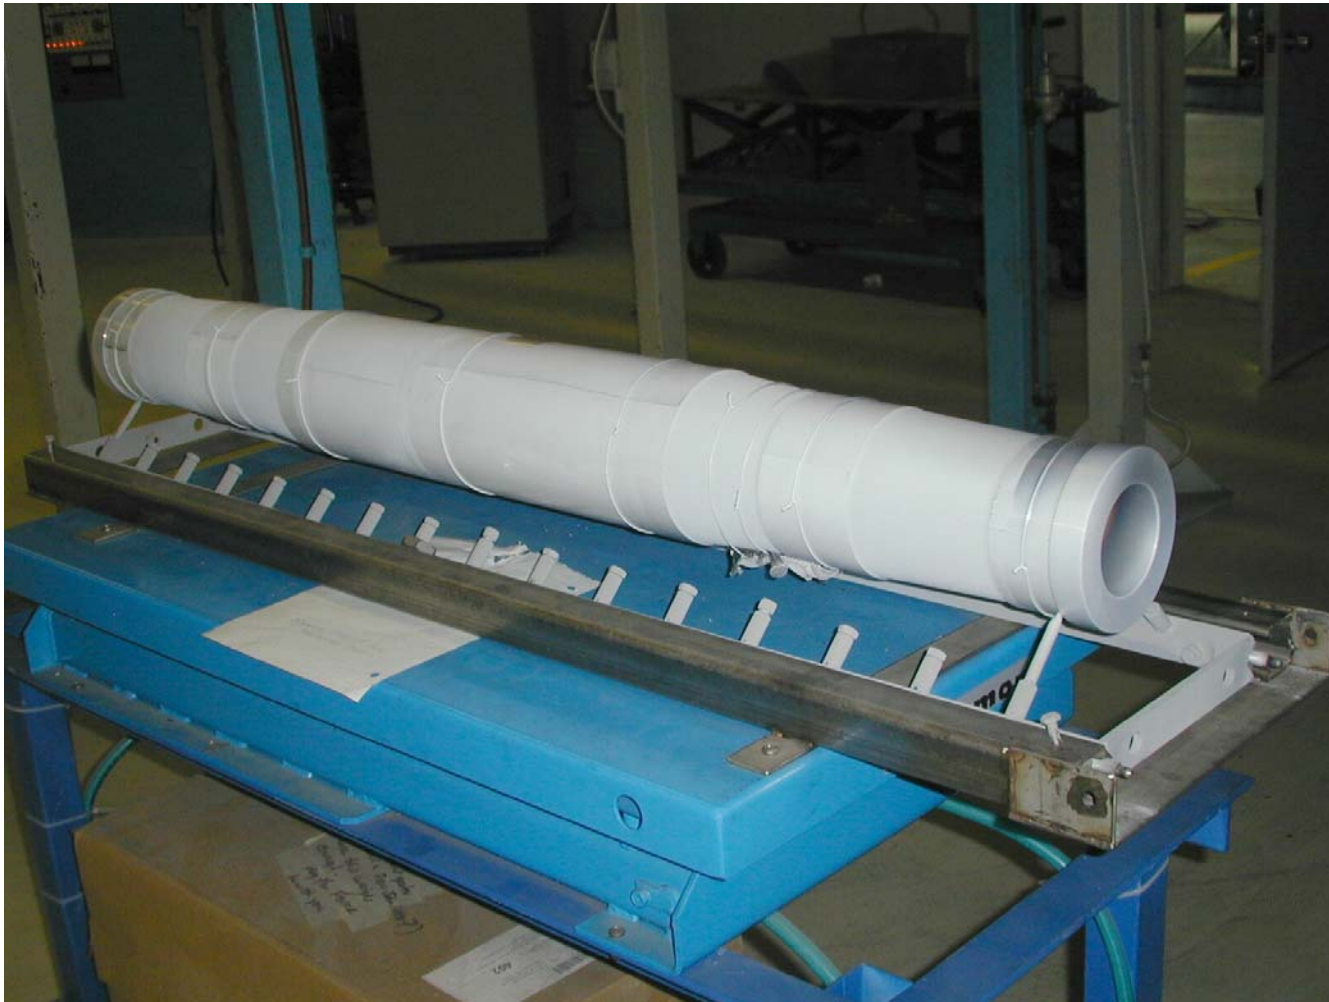
C-17 Long Axle on Coating Rack

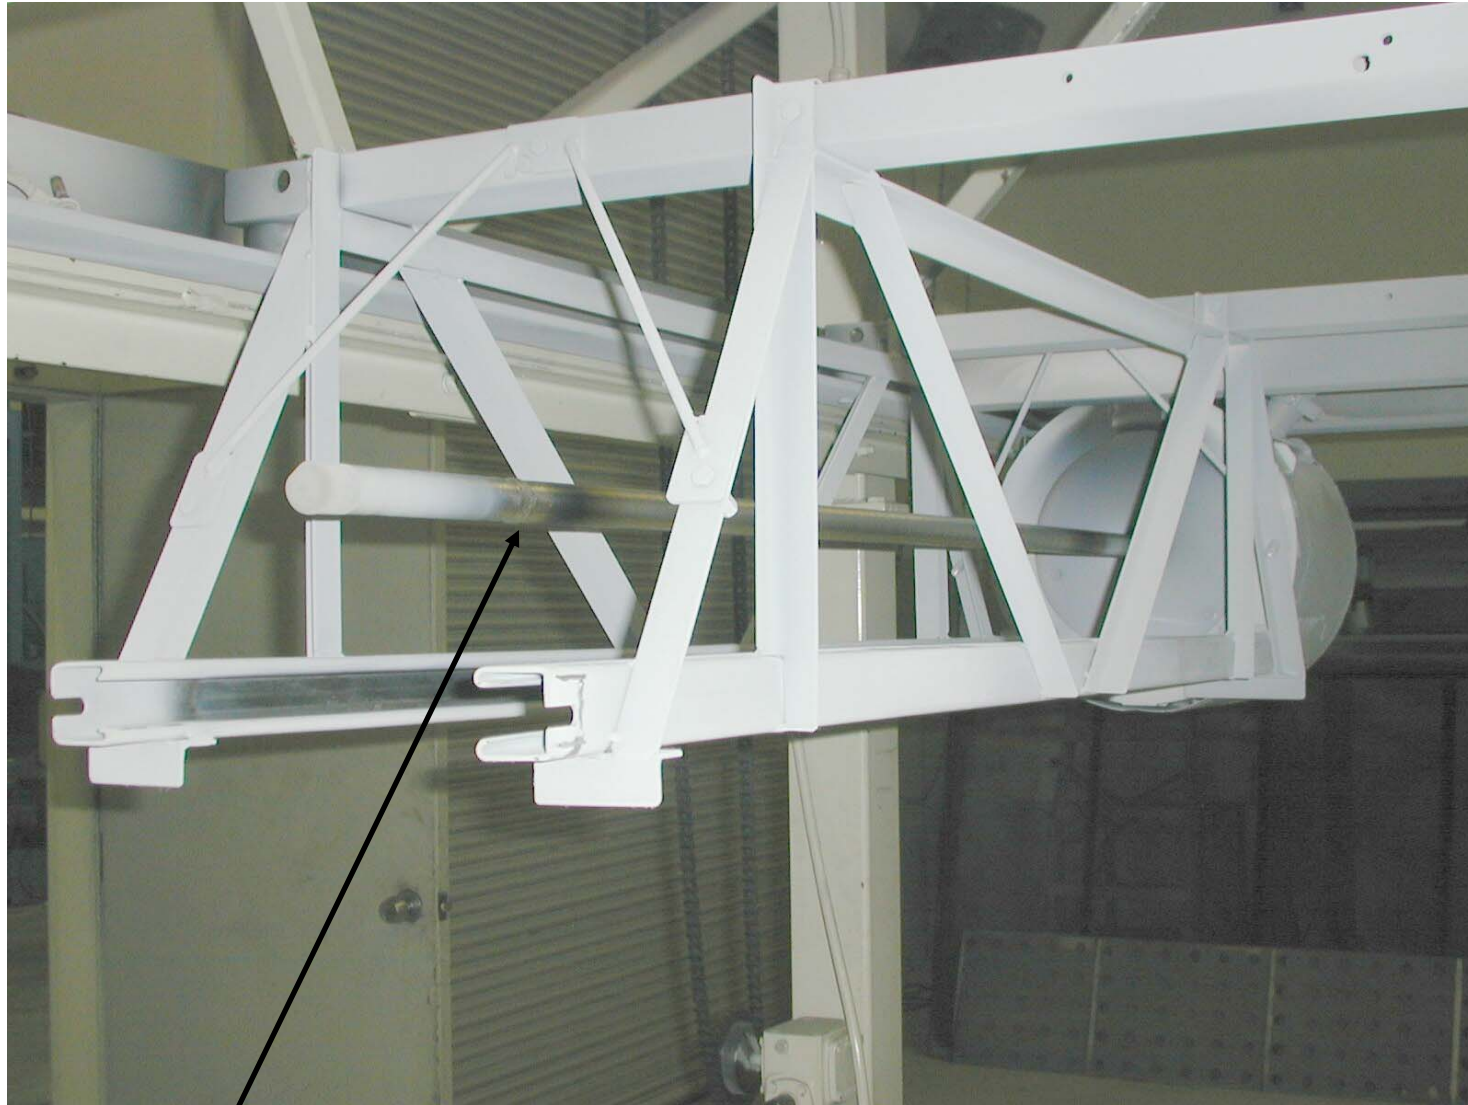
Long Aluminum Sputter Probe on IVD Rack

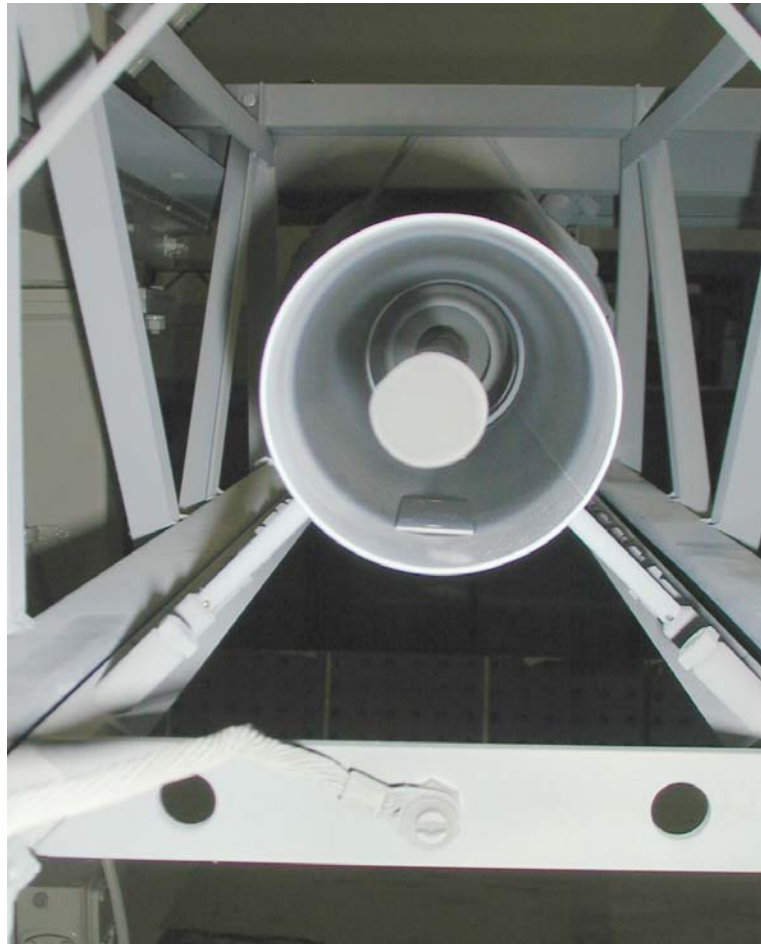
Sputter Probe Aligned In Center of Part

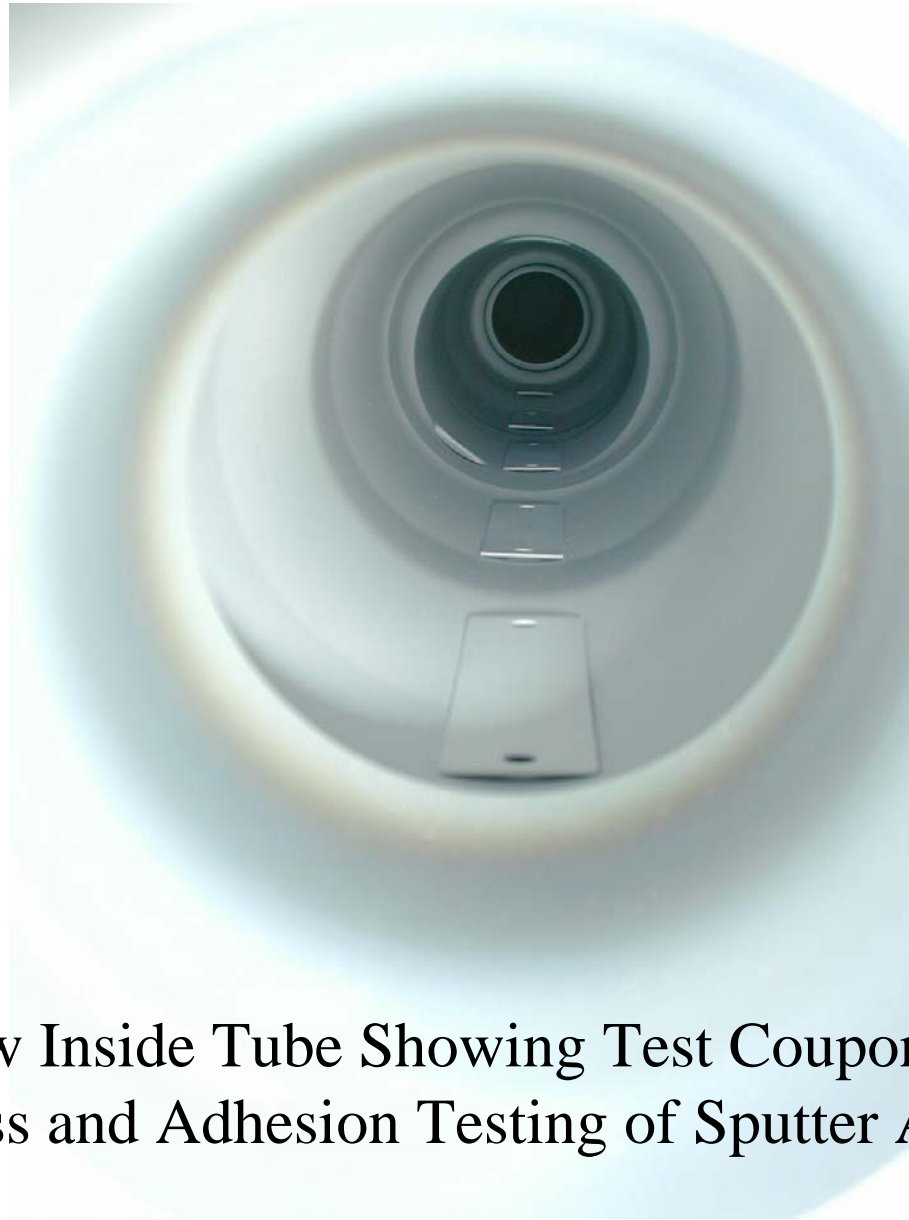
View Inside Tube Showing Test Coupons for
Thickness and Adhesion Testing of Sputter Al Coating

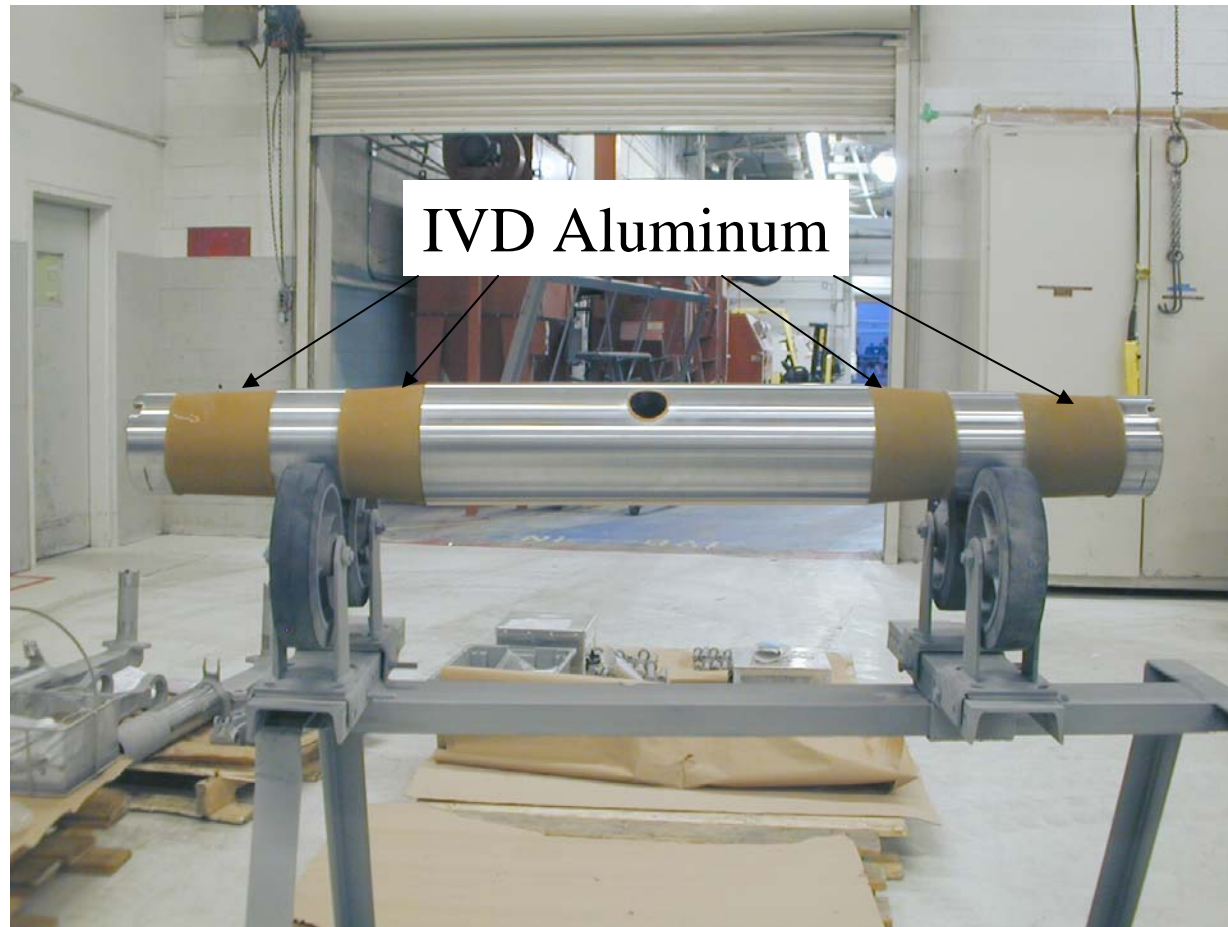
C-17 Axle After Conversion Coating

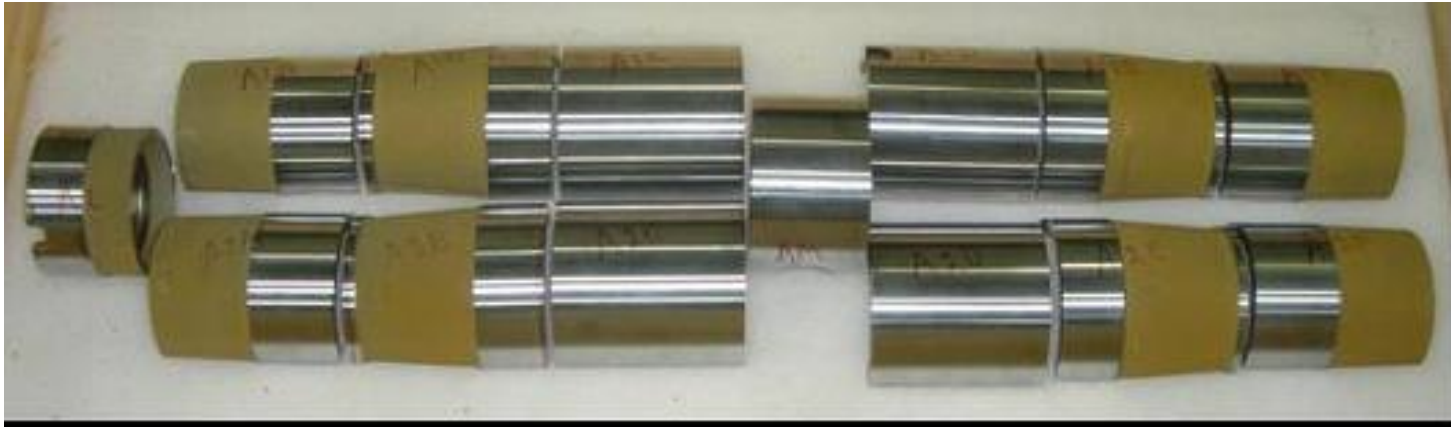
C-17 Long MLG Axle Cut Into Test Specimens.

Top is OD and bottom is ID. Gold-brown areas are IVD aluminum (on the OD) and Sputter aluminum (on the ID) with conversion coating applied.

- Initial Testing
 - Cut Up Axles Into 6” Tubes and Split Each Tube in Half (Along Length)
 - Check Thickness
 - Checked Sputter Aluminum and Paint Coatings
 - Check Adhesion
 - Adhesion of Sputter Aluminum to Steel
 - Tape Adhesion and Glass Bead Burnishing (20 - 80 psig)
 - Adhesion of Paint to Sputter Aluminum and Steel
 - Scribed Dry and Wet Tape Tests

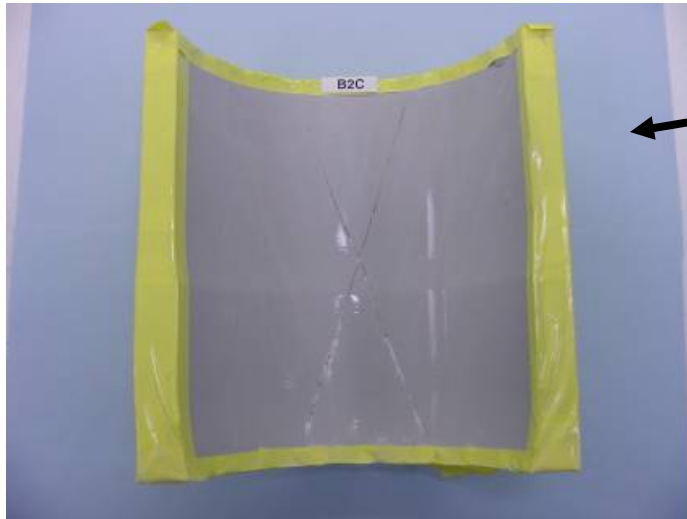
Sputter Aluminum + Primer +
Polyurethane Topcoat –
NO CORROSION!

- Axles B, C and D Subjected to Unscribed and Scribed Salt Spray (ASTM B 117)
 - B = Sputter Aluminum + Paint
 - C = Bare Steel + Paint + CPC
 - D = Sputter Aluminum Only
- ID Surface of Axles Tested for 1000 Hour Exposure

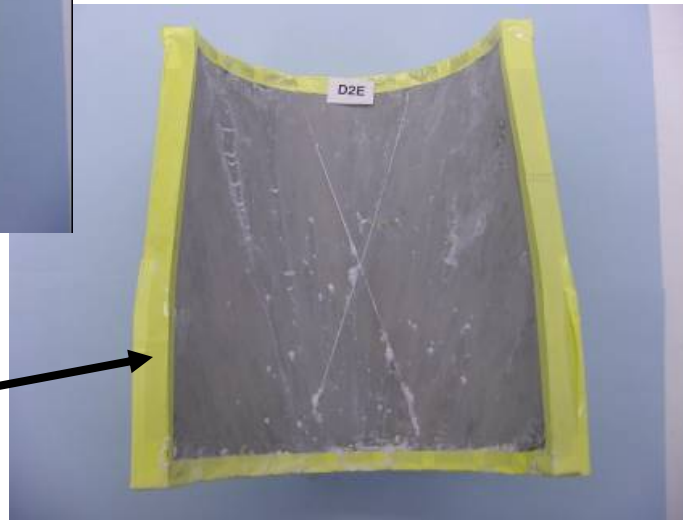
Sputter Aluminum –
White Corrosion

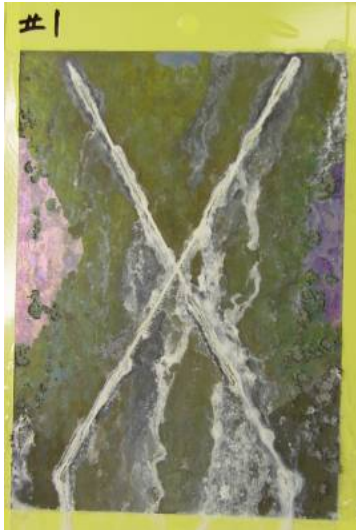
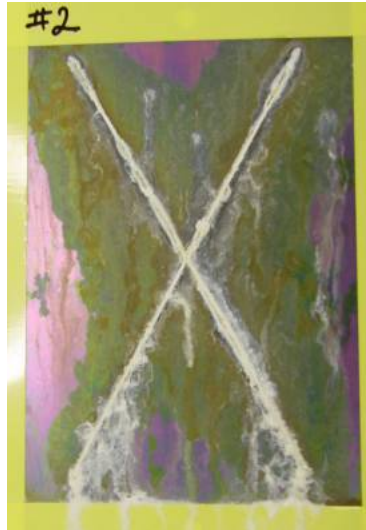
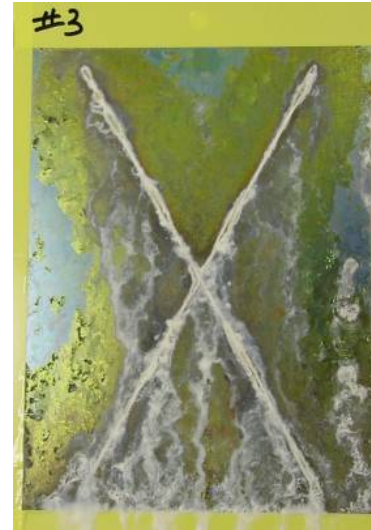
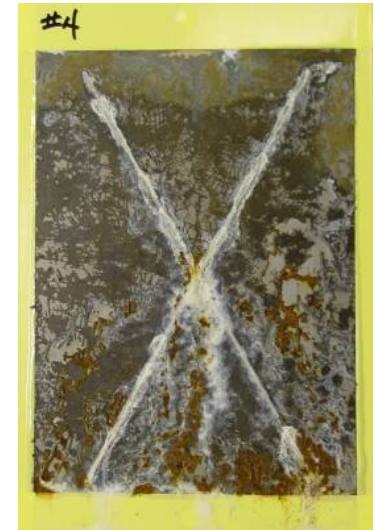
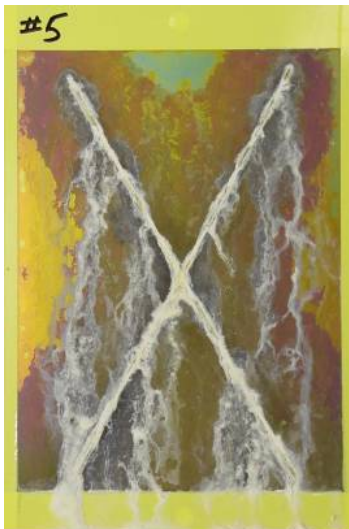
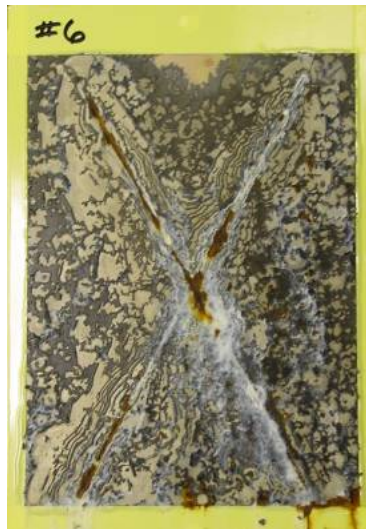
- Develop and Evaluate LHE Alkaline Zn-Ni
 - Work with an Experienced Plating Vendor
- Evaluated Seven Potential Formulations
 - Corrosion (Scribed and Unscribed)
 - Thickness / Composition
 - Hydrogen Embrittlement
- Not All Zn-Ni Perform the Same Way
 - See Corrosion Test Results

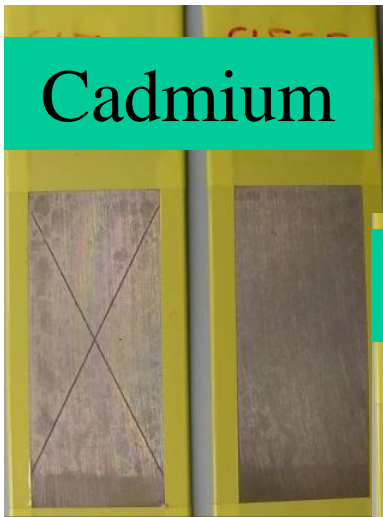
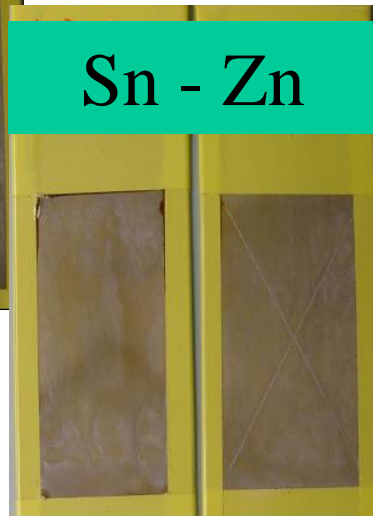
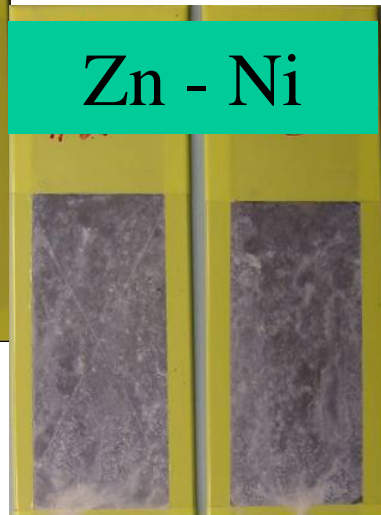
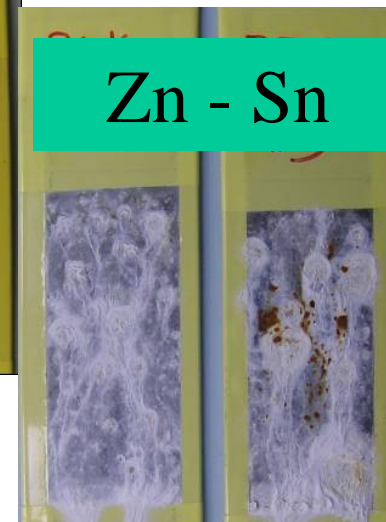
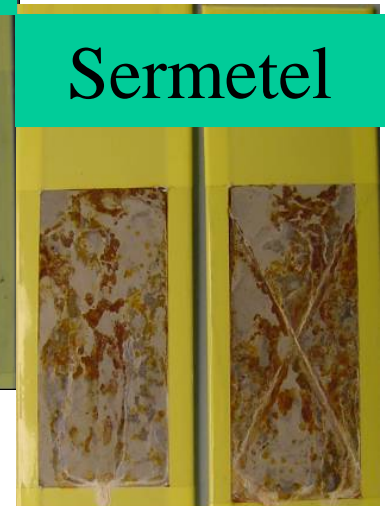
After 672 Hours in Salt Spray

- Need Brush Cadmium Alternative Repair for High Strength Steels
 - No Bake after Plating!
 - Zn-Ni
 - Sn-Zn
 - Zn-Sn
 - Others
- Sn-Zn is Very Promising
 - Acceptable Corrosion and HE Performance
 - More Testing Required
